DP-300566  
2/5

Zirconia Body Electrode Resistivity  
Stability Comparison  
by AC Complex Impedance Measurements

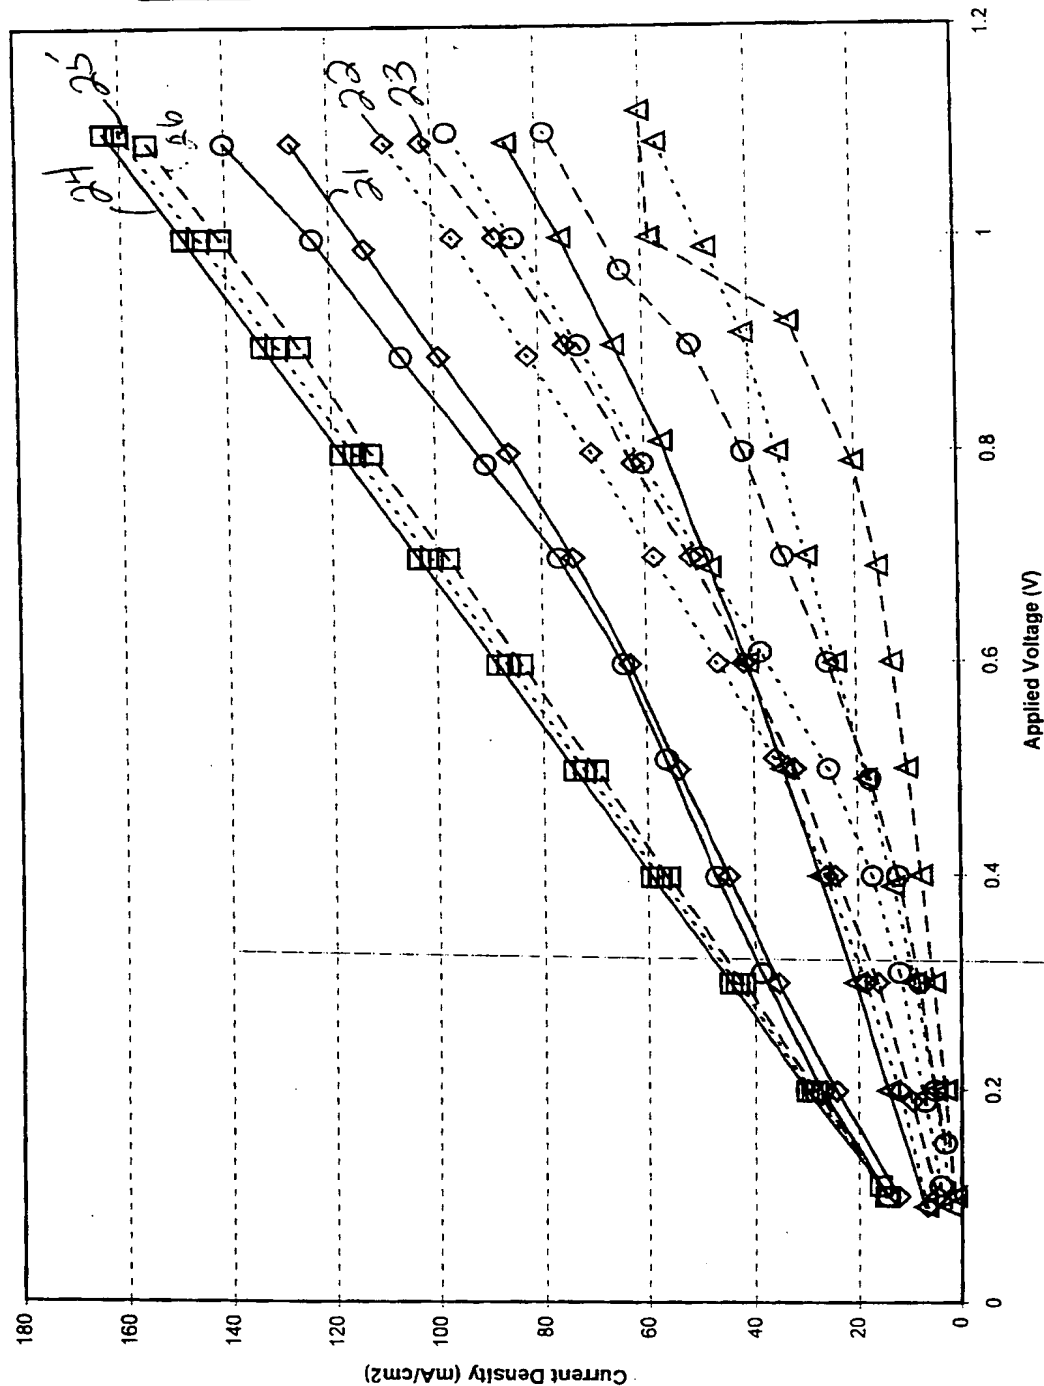
Air Atmosphere

Disk Samples  
1144 Cofred Electrodes

Normalized Current Density  
Initial and Aged

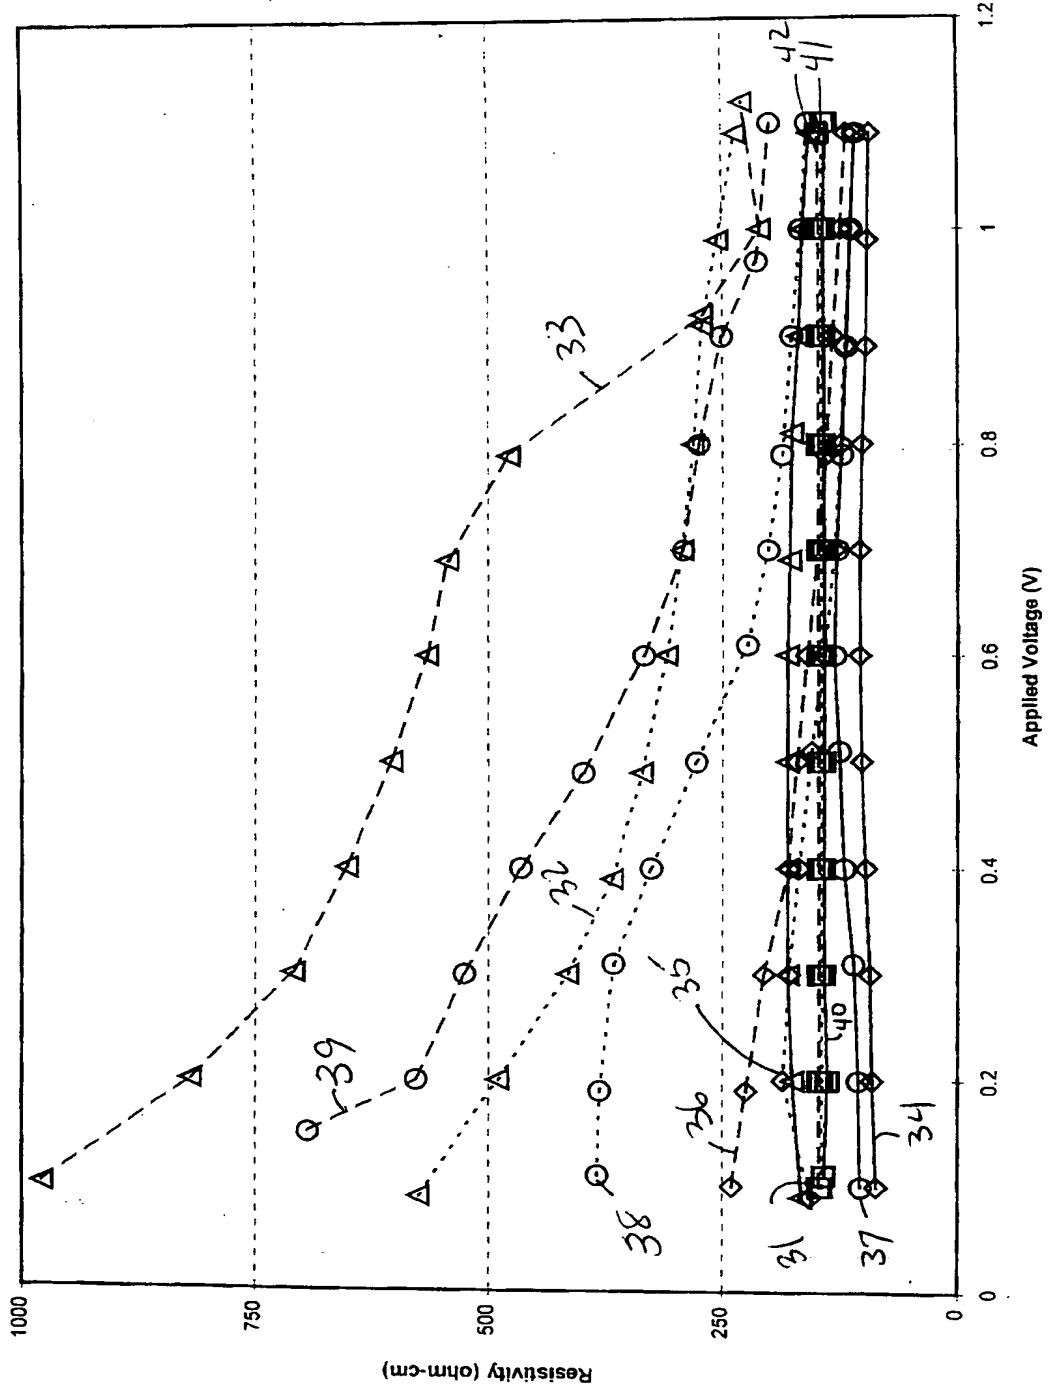
Disk Samples  
I144 Cofired Electrodes

Air Atmosphere

DC Volume Resistivity  
Initial and Aged
